# amroth case study

Amroth is a small coastal village situated in South Pembrokeshire. It's main income is through the tourist industry. In the past the area has relied upon the nearby coal mine at Stepaside as it's main source of revenue. Coal reached the port at Saundersfoot along a raliway which ran along the top of an embankment built for this purpose in 1840. Anthracite mining was also an important part of the local economy until the end of the 19th centruy.

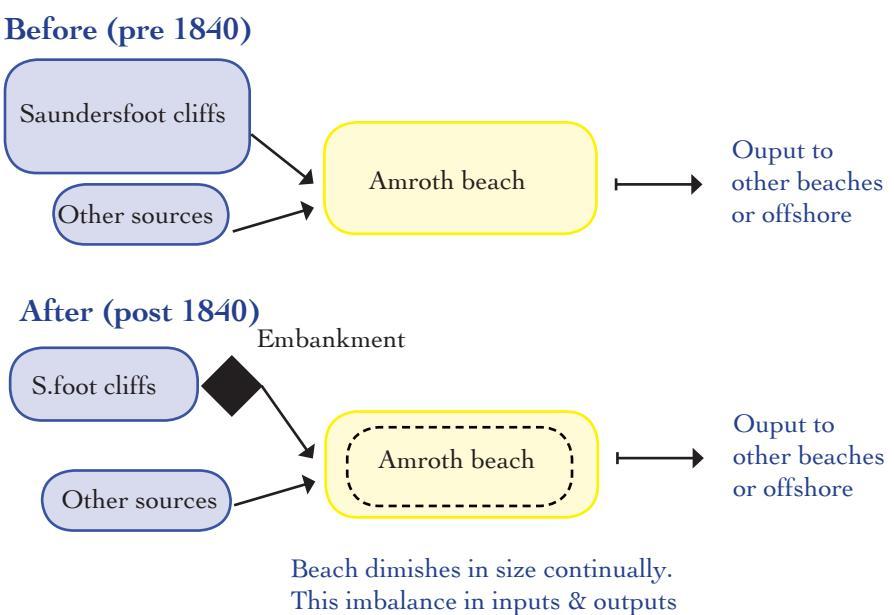
The beach at Amroth relied upon recharge from the cliffs at Saundersfoot. The sediment was carried along the shore to Amroth by LSD. When this erosion was reduced by the building of a railway embankment, the beach at Amroth lost one of it's inputs and thus began to diminish in size, the outputs now outweighing the inputs, as sediment continued to be removed from the beach by LSD at the North end. The below systems diagram illustrates this.

isn't noticed for 30 years.
