# Sustainable river management: Roding & Kissimmee

## Roding

## Kissimmee

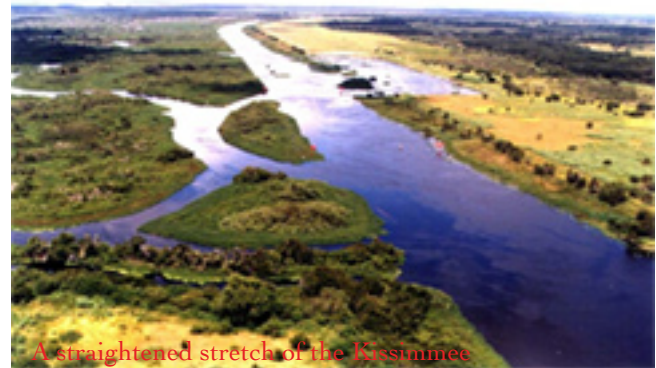
A straightened stretch of the Kissimmee

- A hurricane in 1947 acted as the catalyst for management of this increasingly urbanised area
- Channelisation took place
  - » Straightened and deepened (165-90km)
  - » 2500 ha of wetlands lost
- Deep trenches built across plain for drainage and future developments
